Manhole Inspection Summary

Manhole # S01WW1013MH

Insp Date: **7/31/06 10:56 AM**

Location Address: **5906 Park Heights Ave**

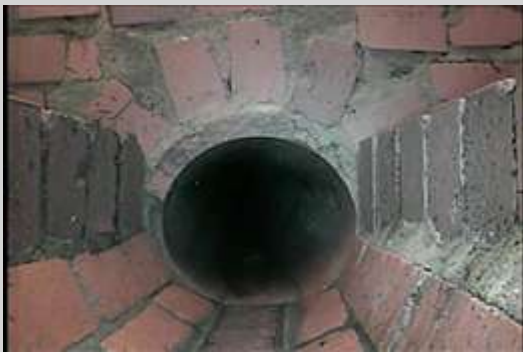
8 in. Circular Gravity Sewer Pipe Out @ 12 O'Clock

Pipe Material: **Clay** ☐ Pipe Lined

Invert Depth: **7.14** (ft.) Flow Characteristics: **Slow**

Deposits: ☒ None ☐ Mud ☐ Sludge ☐ Debris ☐ Grease

Infiltration: **None** Pipe Seal Cond: **Sound**

Drop: **None**

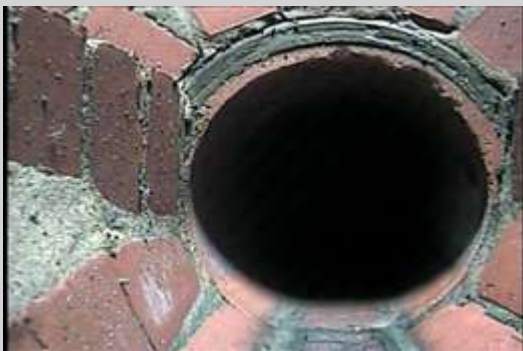
8 in. Circular Gravity Sewer Pipe In @ 8 O'Clock

Pipe Material: **Clay** ☐ Pipe Lined

Invert Depth: **7.01** (ft.) Flow Characteristics: **Slow**

Deposits: ☒ None ☐ Mud ☐ Sludge ☐ Debris ☐ Grease

Infiltration: **None** Pipe Seal Cond: **Sound**

Drop: **None**
